CAMSHAFT TIMING

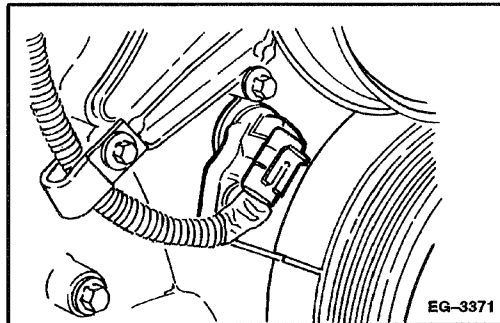
Figure 4.1. – Timing Pointer Aligned with Mark on Damper

- Bar engine over by hand until pointer on camshaft position sensor (CMP) is aligned with the machined timing slot on the crankshaft damper. **Figure 4.1.**
- Remove CMP sensor and view timing disk through the CMP hole in the front cover.
- If the engine is on the compression stroke for #1 cylinder a narrow sync vane will be observed directly in the middle of the CMP sensor hole. **Figure 4.2.**
- If the camshaft timing is either one tooth advanced or retarded the narrow vane will appear approximately 1/8" from either the upper or lower edge of the hole.
- If no narrow vane is visible it is most likely that the engine is not on the compression stroke for #1 cylinder. **Figure 4.3.** Temporarily install CMP sensor, bar the engine over 360° until the CMP sensor pointer and the line on the crankshaft damper are aligned and re-inspect for the narrow vane on the timing disk.

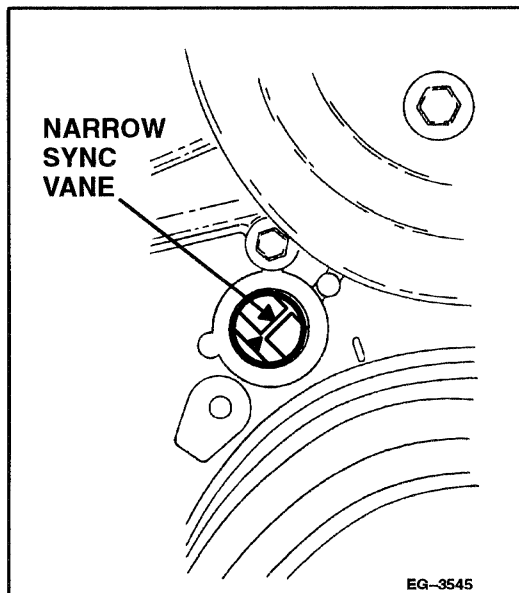
Figure 4.2. – View of Timing Disk
(Camshaft Timing Correct)

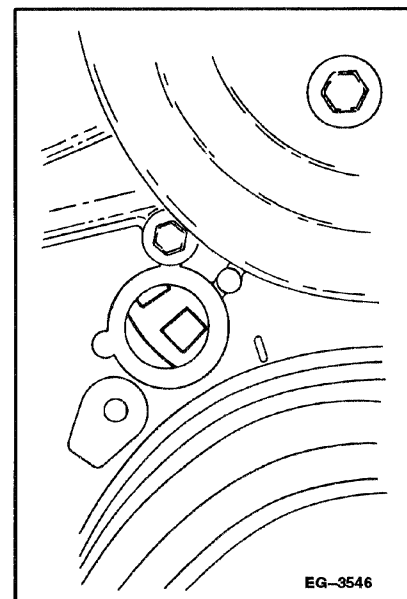
Figure 4.3. – View of Timing Disk
(Not on Cyl. #1 Compression Stroke)
Rotate Crankshaft 360°
