SUPPLEMENTAL DIAGNOSTIC ANALYSIS

ECM RESET

(GLOW PLUG LAMP CYCLES ON/GLOW PLUGS RECYCLE/ ENGINE STUMBLE DIE/NO ACCELERATOR PEDAL AUTHORITY UNTIL RETURN TO IDLE POSITION)

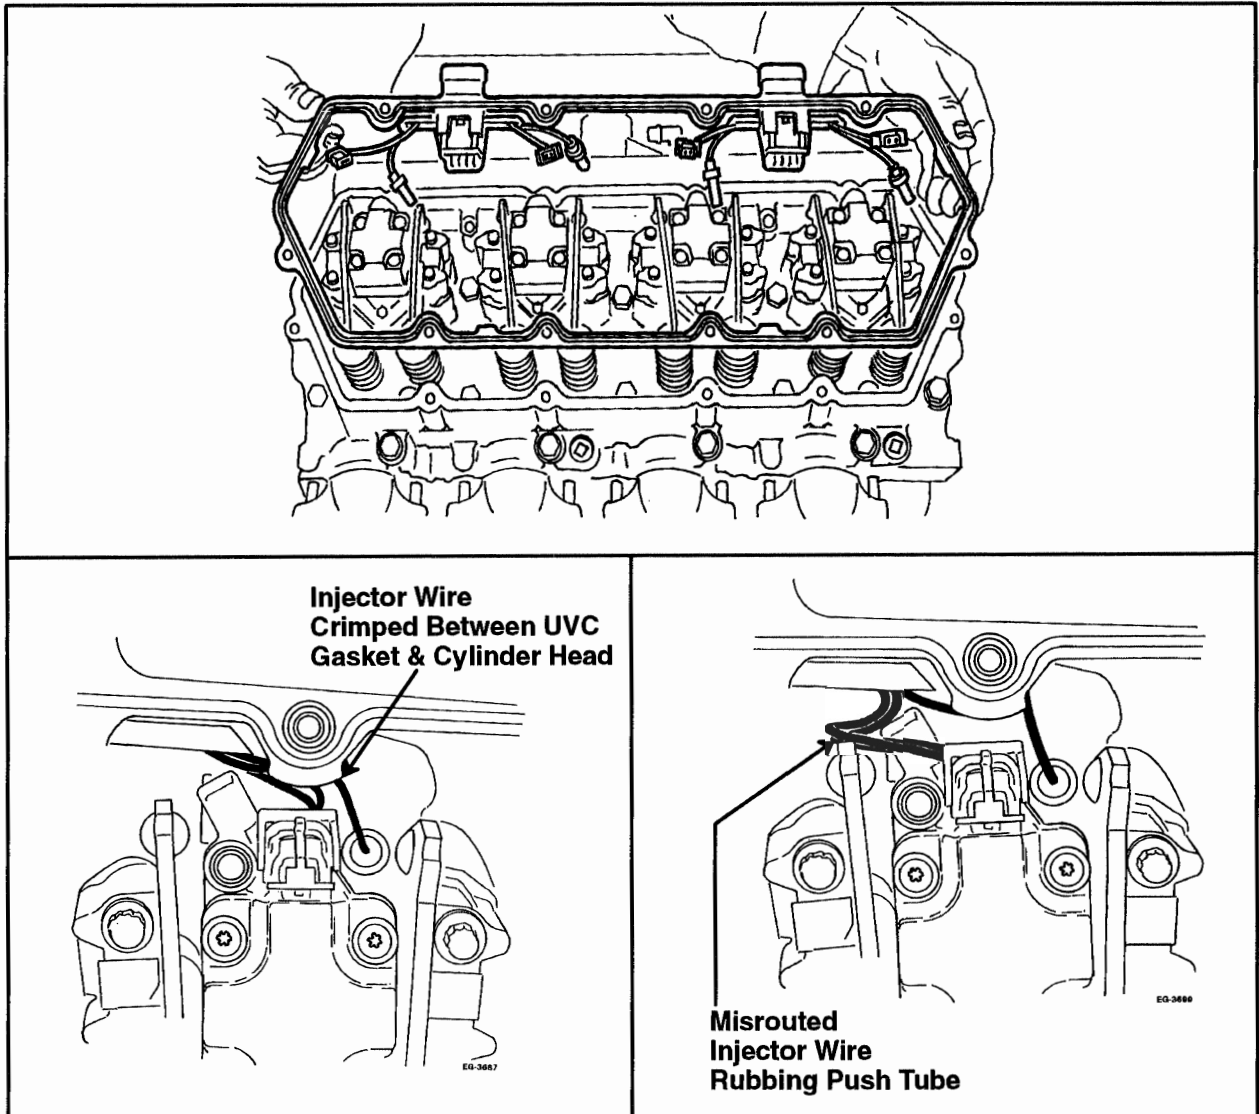
- Remove the valve covers and inspect the under valve cover connectors (**Figure 4.19.**) for possible pinching under the valve cover gasket or rub through against the push tubes.

Figure 4.19. – Under Valve Cover Harness Inspection
